# How to fix the display issue on Maschine MKII

Maschine is a great product, but it's construction has not been thought through entirely. Here's how to fix a common issue with the Mk2 units.

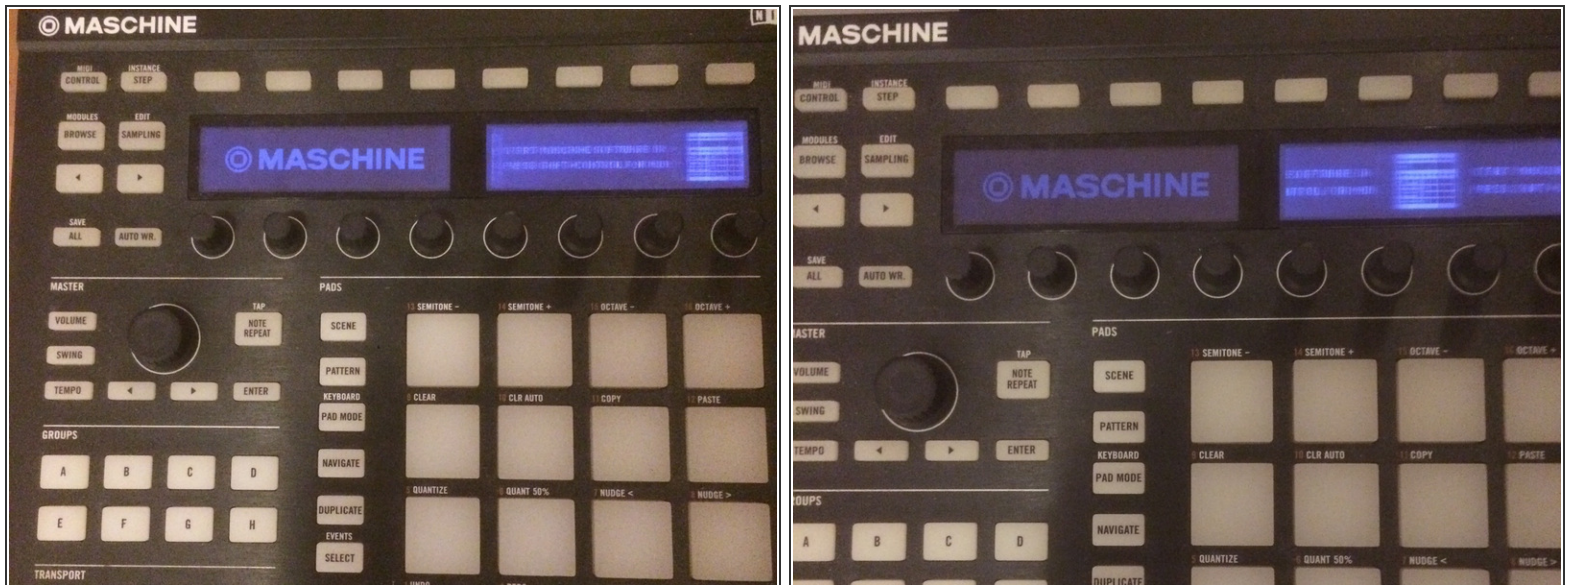
## Step 1 — Diagnose

- As you can see the right display is brighter, and fuzzy.

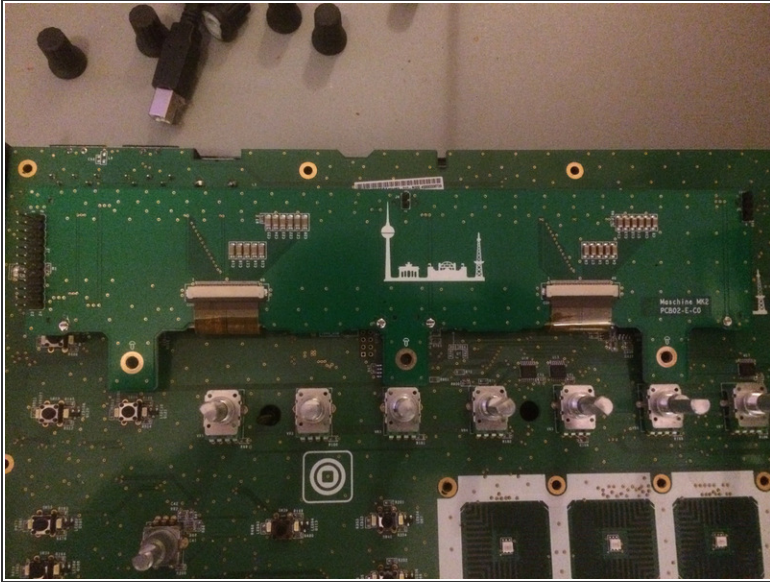
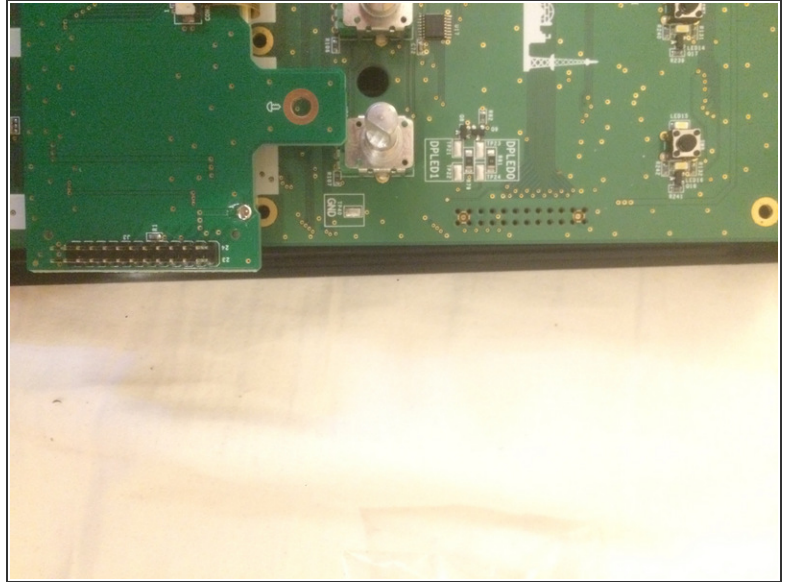
## Step 5

- this is the backside of the display unit.
- it connects with the main PCB using a push-through connection. They should have used longer pins, conductive springs for this instead.

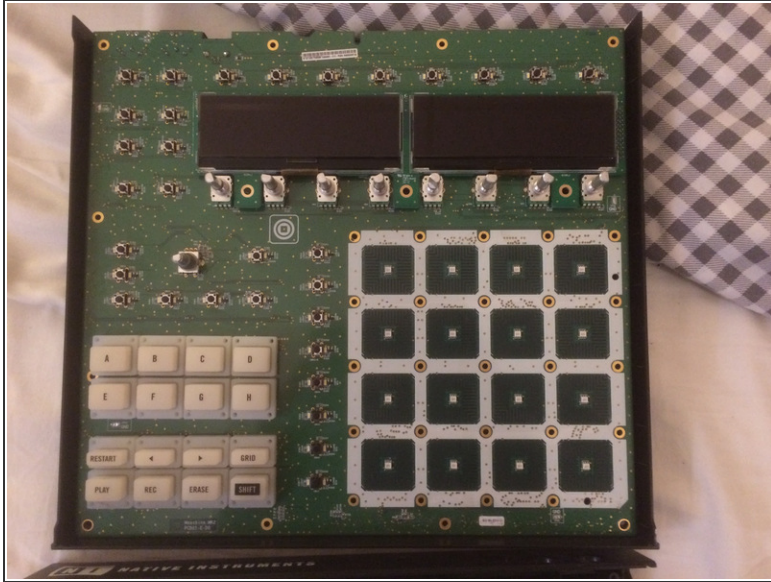
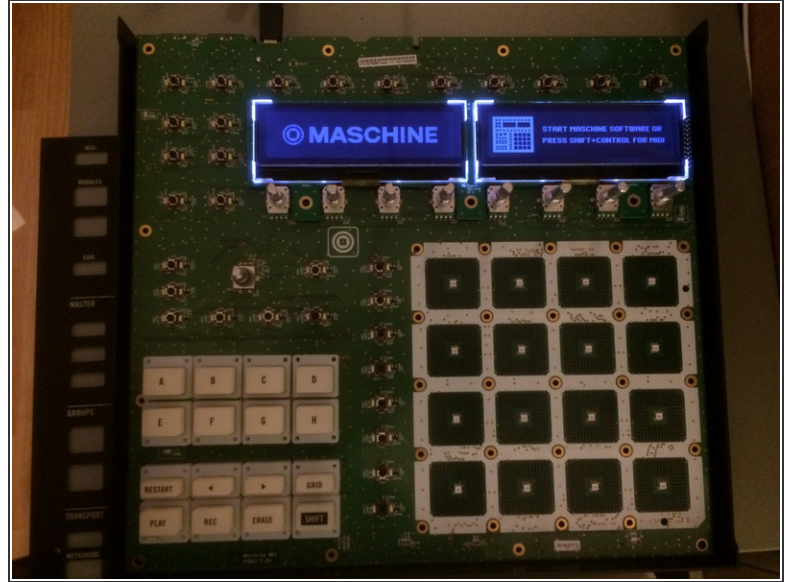
## Step 6

- I put it in the bottom panel, so I could test if the issue persisted on the PCB. I also inspected the PCB for oxidation to make sure it wasn't water damage, since I got it second hand.
- After plugging in the device, and fiddling with the display connection to the right it turned out to be functioning properly, but looked broken due to a design flaw.
